CALSPAN ON-SITE NON-DEPLOYMENT AIR BAG INVESTIGATION  
CALSPAN CASE NO. 92-20  
LOCATION - [REDACTED] ME  
ACCIDENT DATE - [REDACTED] 1992

16. <i>Abstract</i>  This on-site investigation focused on a low-speed crash that involved a police 1992 Chevrolet Caprice that was equipped with a Supplemental Inflatable Restraint (SIR) system which consisted of a driver's side air bag. The vehicle impacted a wooden utility pole with the right frontal area that resulted in 28.4 cm (11.2") of bumper crush. The damage and trajectory mode of the CRASHPC program was utilized to compute an impact speed of 23 KPH (14 mph) and a total (longitudinal) velocity change of 21 KPH (13 mph). The velocity change was below the manufacturer-reported 24 KPH (15 mph) centerline pole impact deployment threshold for this vehicle and therefore, the driver air bag system did not deploy.  The driver of the vehicle was a 50 year old on-duty police officer. He was wearing a bulletproof vest; however, he was not wearing the manual 3-point lap and shoulder belt system. At impact, he initiated a forward trajectory and loaded the steering assembly with his thoracic area. His loading force compressed the energy absorbing s

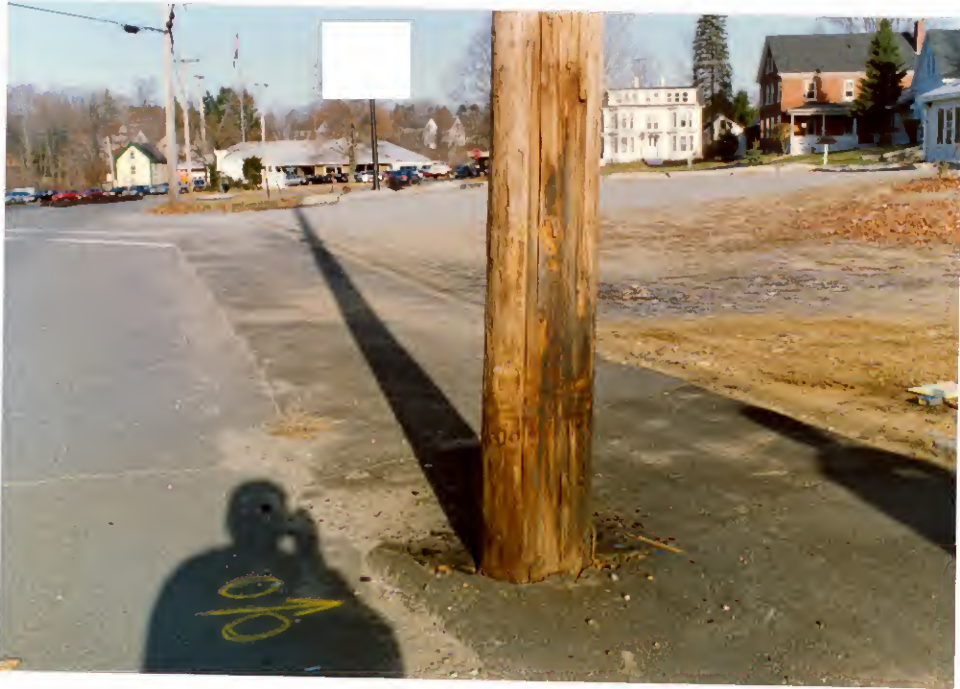
Struck utility pole

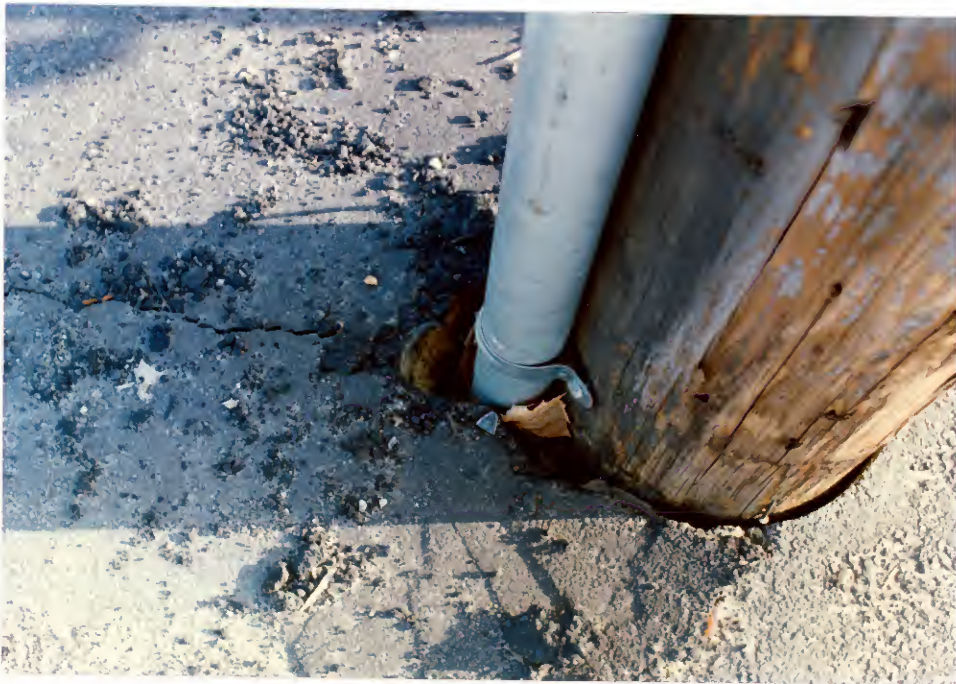
7cm (2.75") displacement of pole

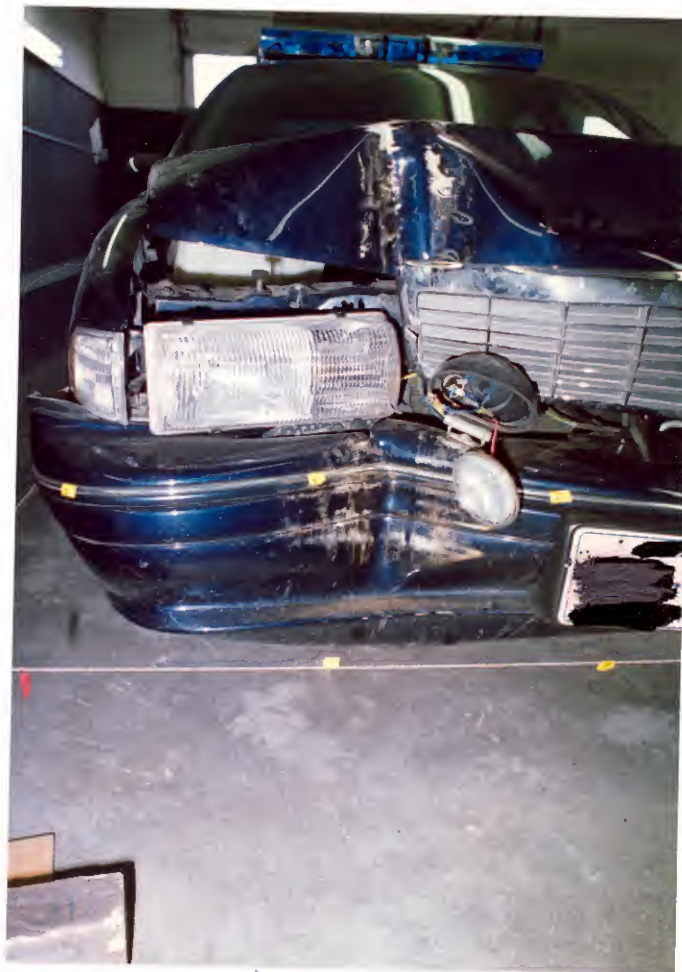
The utility pole impact buckled the upper rail of the radiator support panel and displaced the right frame rail which resulted in a 1cm (0.4") reduction of the right wheelbase. Damaged components included the front bumper facia, bumper reinforcement bar, both front bumper energy absorbing devices (EADs), right frame rail, right headlamp assembly, grille, radiator support panel, and the hood. The radiator, air conditioning condensor and the battery, all located directly rearward of the pole impact damage, were not damaged by the crash.

Close-up view of the utility pole impact damage

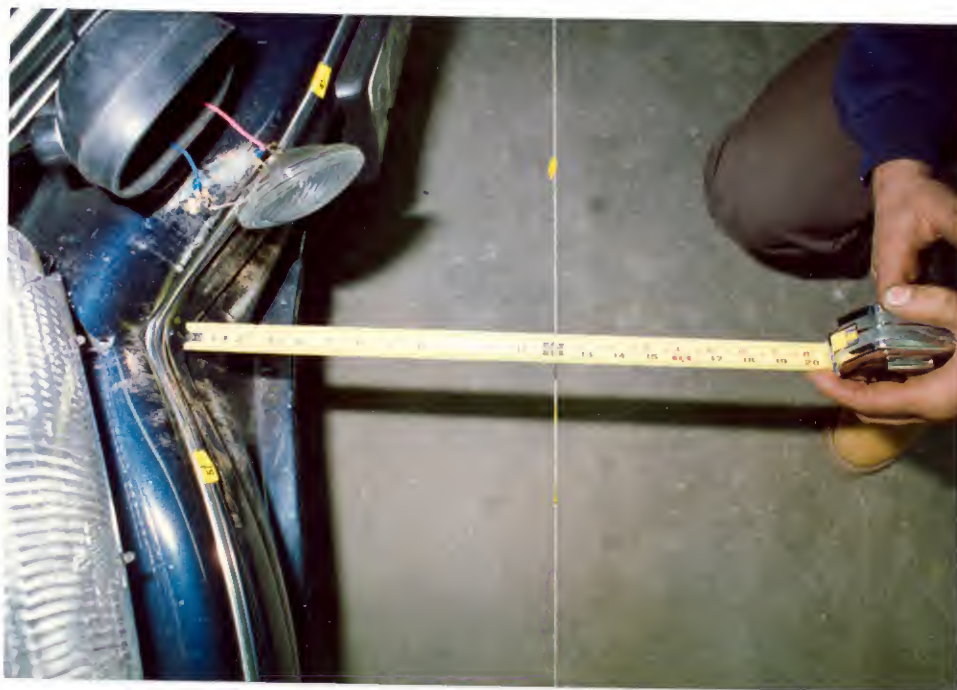
Exterior: The right frontal area of the 1992 Chevrolet Caprice impacted a 26.7cm (10.5") diameter wooden utility pole that was located 0.4m (1.3') outboard of the right roadedge. Direct contact damage began on the front bumper fascia 23.9cm (9.4") right of center and extended 31.8cm (12.5") to the right. The contact damage extended vertically onto the headlamp lens, grille and hood face. The 12 o'clock direction of force impact crushed the bumper reinforcement bar to a maximum depth of 28.4cm (11.2"), located 41.7cm (16.4") right of center. As a result of the impact with the narrow object, the entire width of the bumper was displaced. The combined induced and direct contact damage length was 164.5cm (64.75"). Crush values at bumper level were as follows:

Overhead view showing the extent of crush

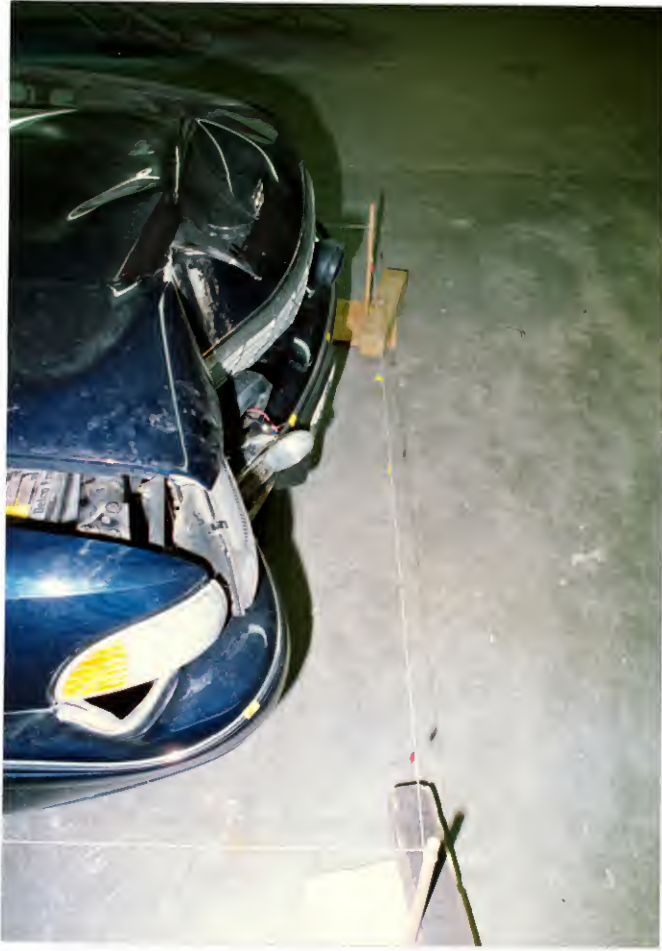
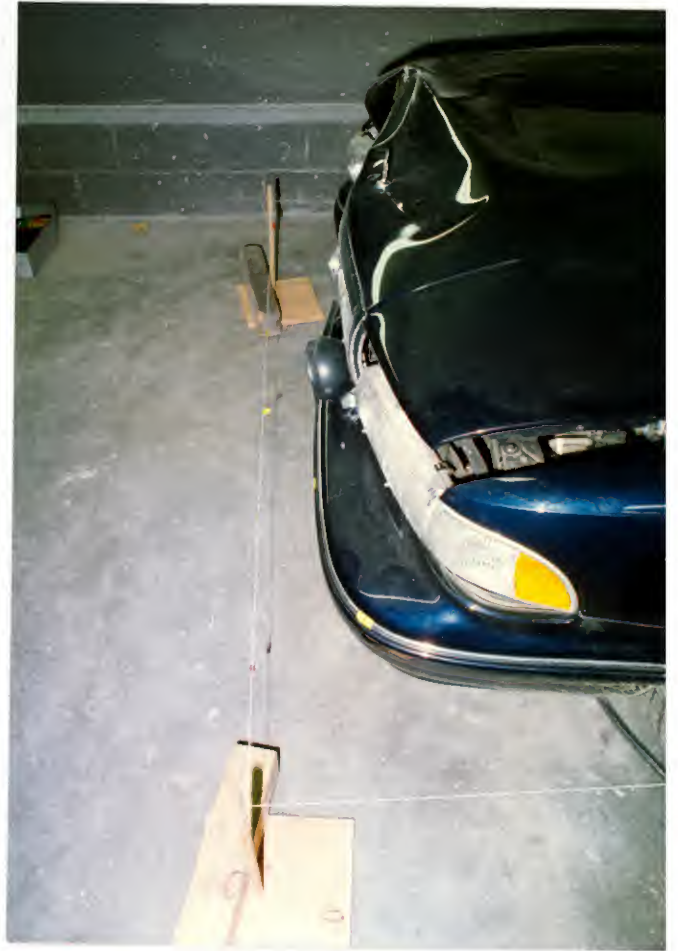
Perpendicular views showing the extent of crush

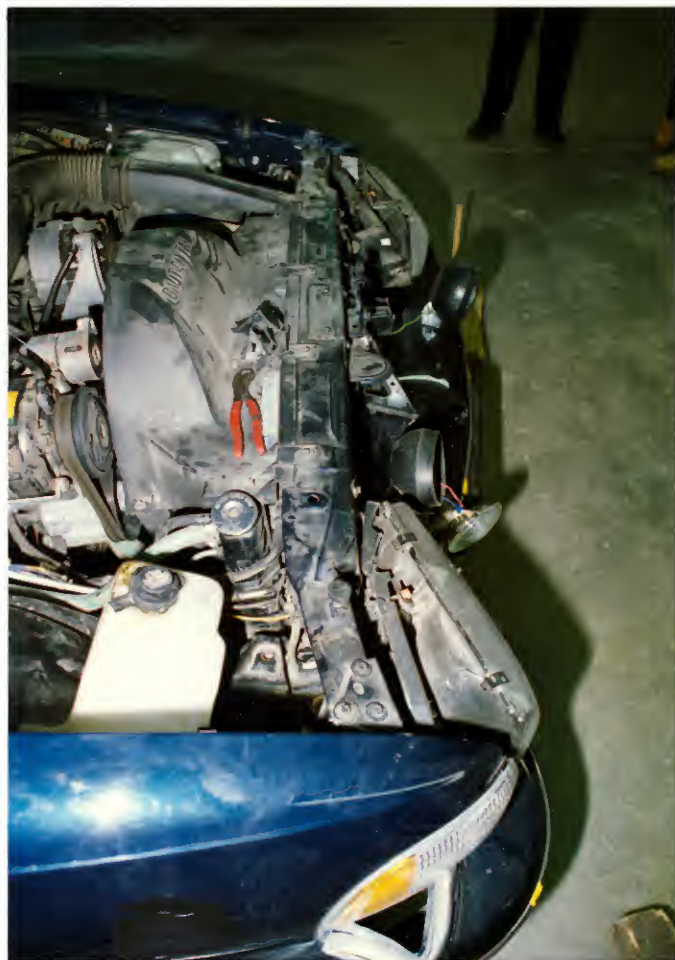
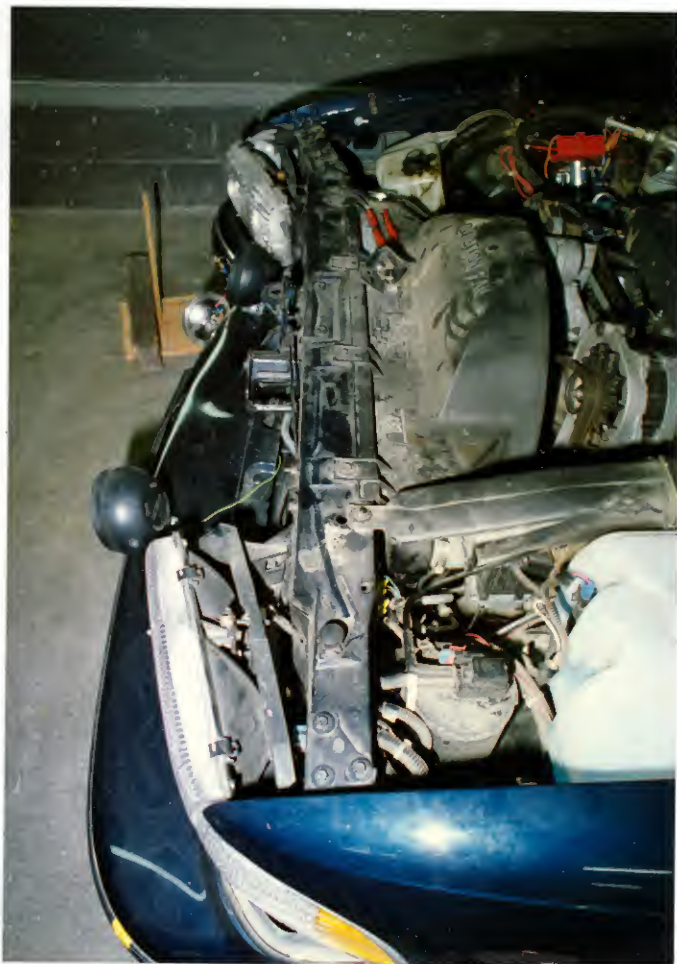
Damaged radiator support panel of the involved Chevrolet Caprice

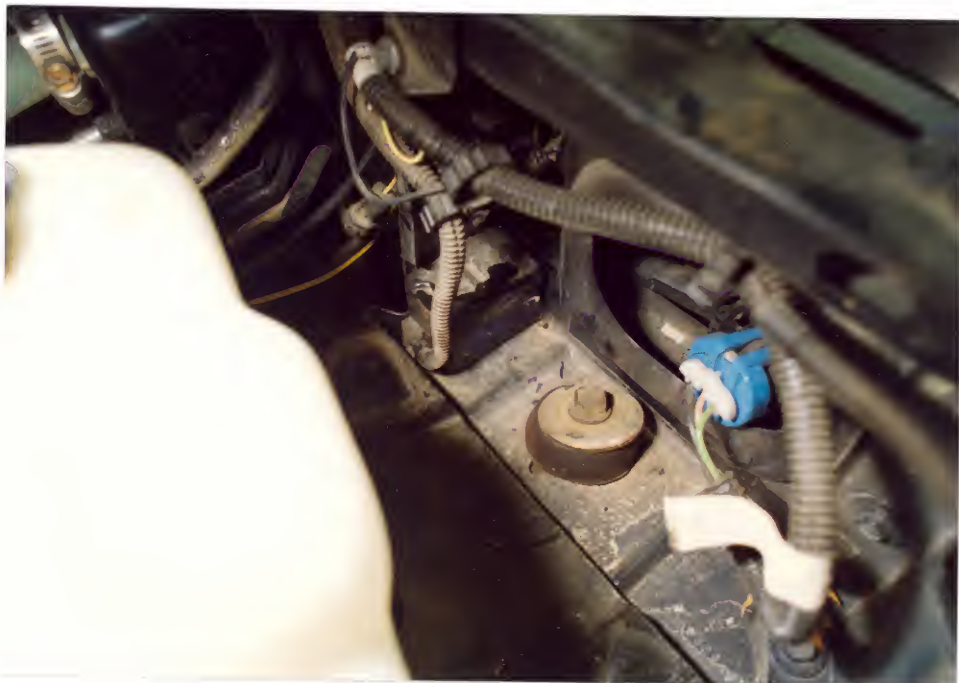
Right front discriminating sensor

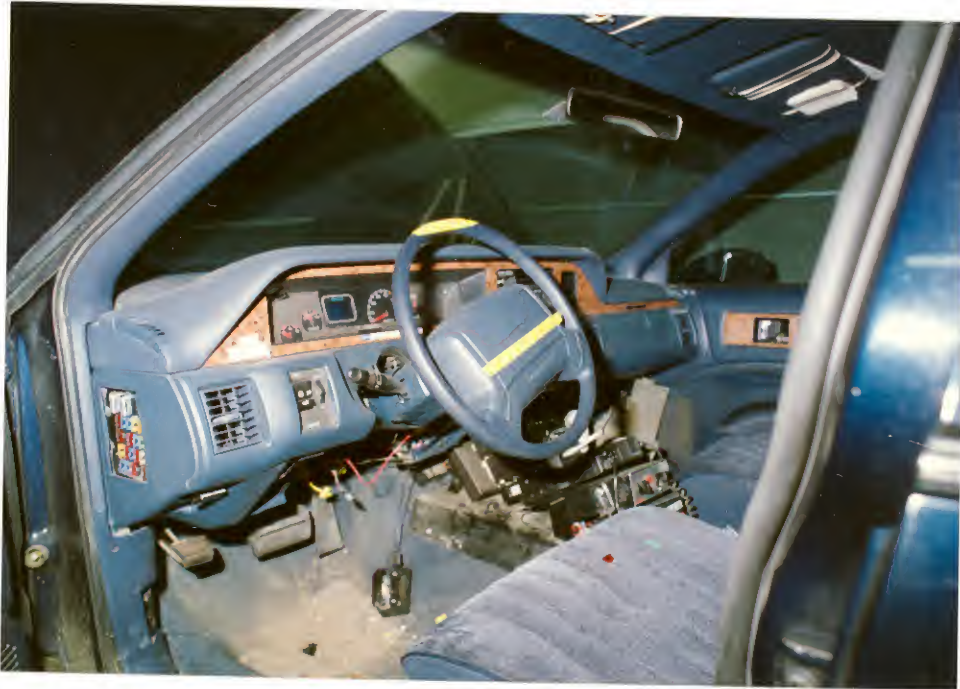
The SIR indicator lamp in the crash involved Chevrolet Caprice did not flash a fault code following the crash. The lamp reportedly flashed for a 6-8 second period then went out and stayed out when the ignition key was placed in the run position. This sequence indicates that the system is armed and operational. Prior to our inspection of the vehicle, the body shop had removed the battery from the vehicle to check for underlying damage. During our inspection process, the battery was reinstalled in the vehicle and the DERM was tested using the indicator lamp. With the ignition switch placed in the run position, the lamp flashed 7-9 times then went out and stayed out. This sequence indicates a normally operating system.

Overall view of the driver's seated position and the non-deployed  
air bag module assembly

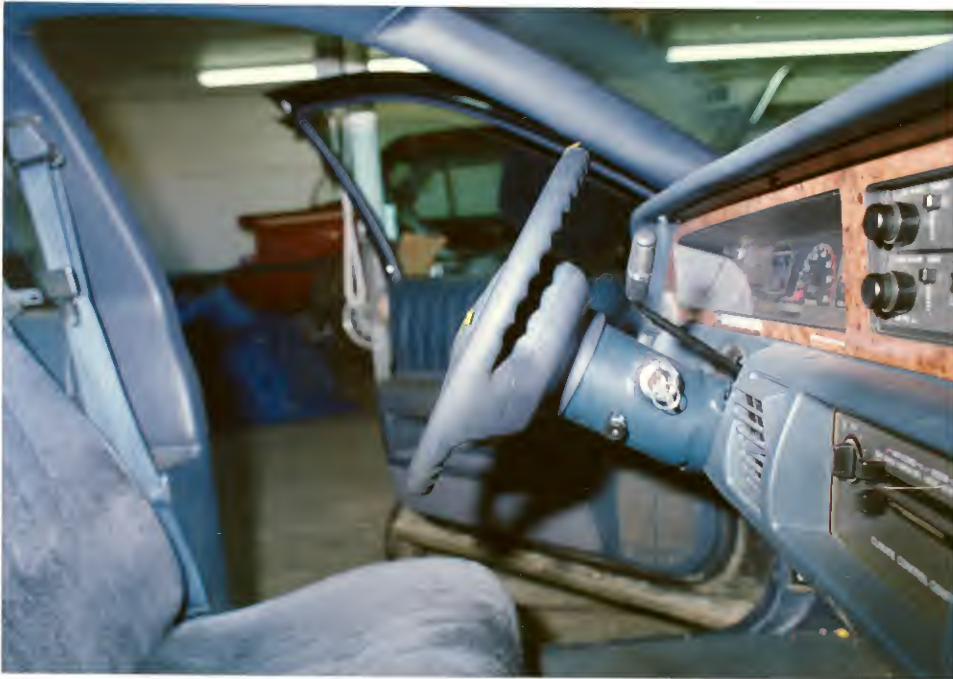
The interior of the Chevrolet Caprice sustained minor damage that was associated solely with occupant contact. The unrestrained driver initiated a forward trajectory in response to the 12 o'clock impact force and loaded the steering wheel rim and air bag module assembly. His loading force minimally displaced the upper steering wheel rim 0.6cm (.25") forward and compressed the energy absorbing steering column 2.5cm (1"). Prior to our inspection, the body shop disassembled the knee bolster and the shear capsules (blocks removed) to inspect the column for damage. There was no damage to the bolster assembly.

Perpendicular view of the steering wheel rim with slight deformation to the upper rim

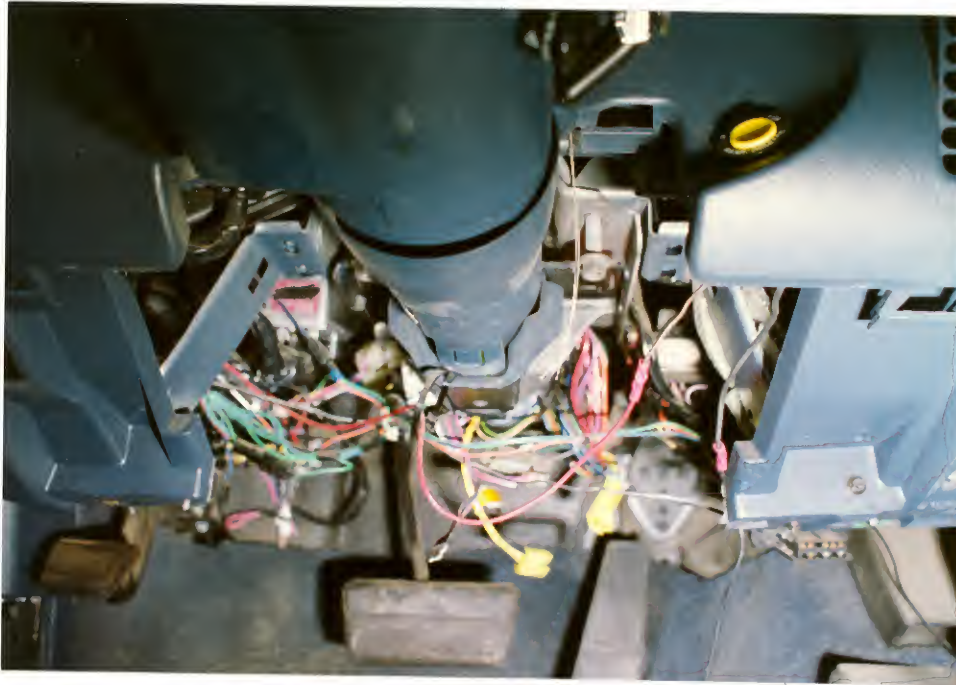
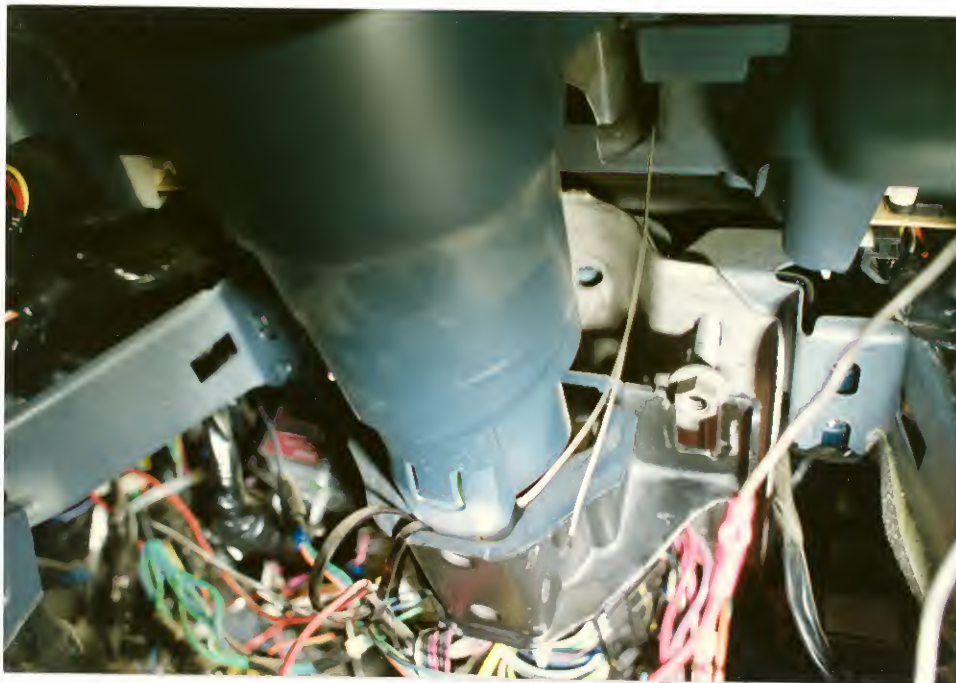
Steering column shear capsule compression (blocks removed)  
and SIR Diagnostic Energy Reserve Module (DERM)

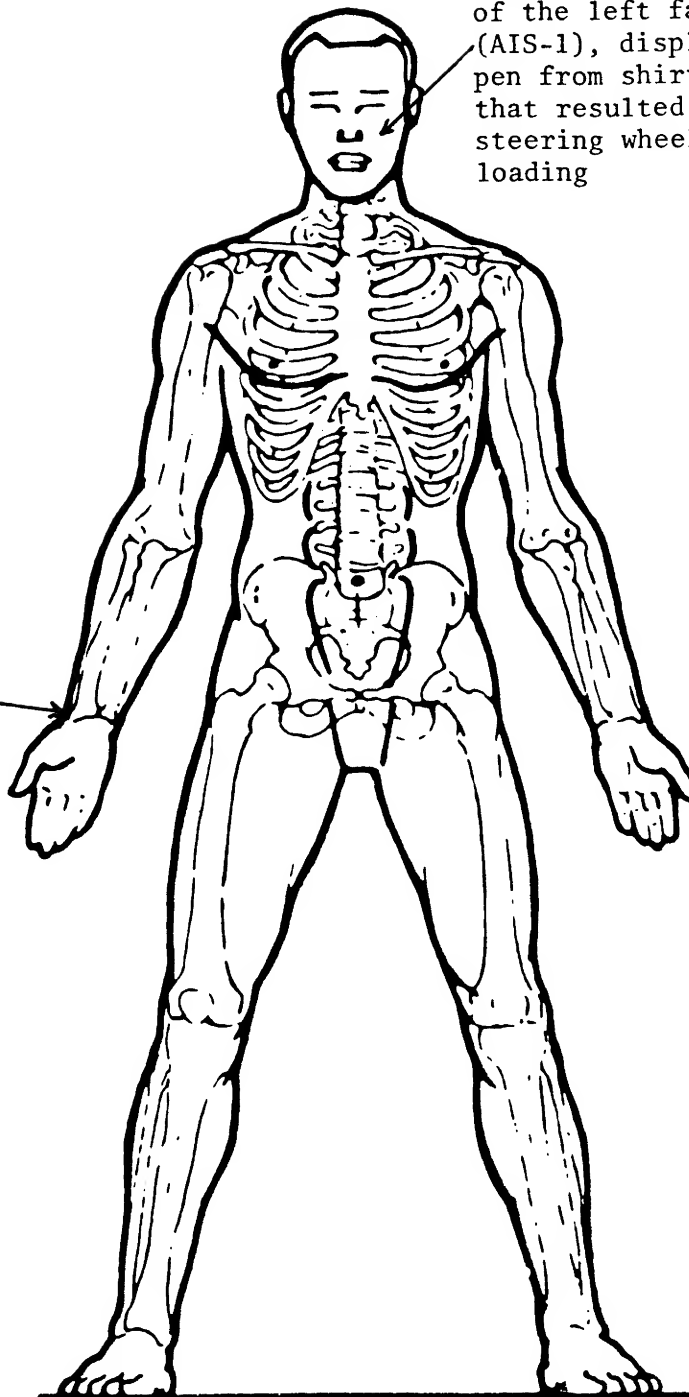
Small abrasion to the  
dorsal aspect of the  
right wrist (AIS-1),  
center mounted  
radio equipment
